McCombie, PF, Mundell, C, Heath, A & Walker, P 2012, 'Drystone retaining walls: ductile engineering structures with tensile strength', *Engineering Structures*, vol. 45, JEST4017, pp. 238-243.
<https://doi.org/10.1016/j.engstruct.2012.06.046>

Drystone retaining walls: ductile engineering structures with tensile strength

Retaining walls; drystone; ductility; assessment.

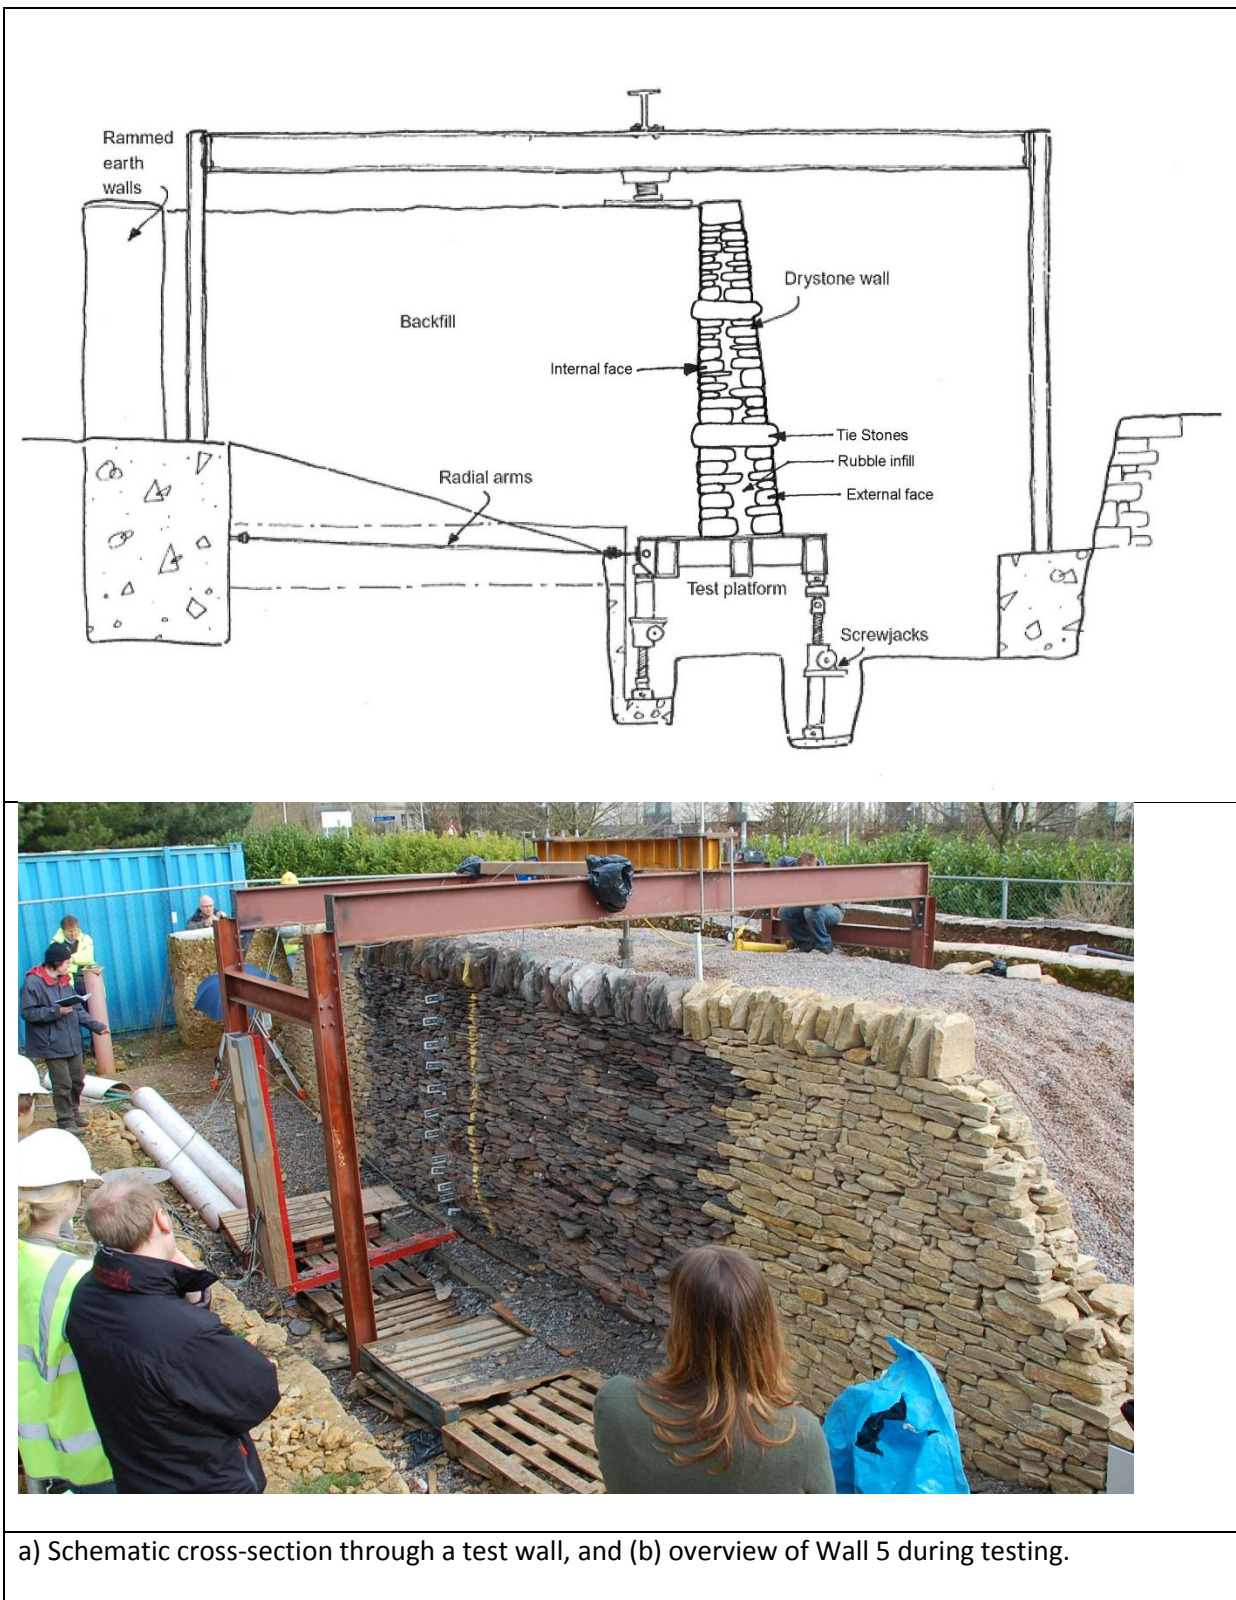
Figure 1 Test arrangement

Following the raising of the platform, a load was applied to the surface of the gravel behind the top of each wall via a 600mm square plate, as seen in Figure 1. The walls began to yield when loads of between 6 and 11 tonne (60 and 110 kN) were applied to this plate, with final collapse occurring only after considerable deformation, as indicated in Table 1. Prior to the final collapse, the load could be removed and all movement of the structures would cease. The walls are shown at their maximum deformations prior to collapse in Figure 2. The targets attached to the wall face were horizontal prior to the application of load to the top of the backfill, and hence indicate the rotation

To address a pressing need for detailed observations of the behaviour of real walls, five test walls were built as summarised in Table 1, each 2.5m high and over 12m long, with a central test section built on a steel platform which could be raised, lowered and tilted under fine control using motorised screw jacks. Hinged transition pieces supported the walls between the platform and the ground to either side, from where wing walls tapered to ground level. The general arrangement of the site is shown in schematic section and photograph in Figure 1. The walls were backfilled with gravel to a height of 2.2m, and the platform raised so that the friction of the backfill on the back of the wall produced a downdrag, as would normally occur during settlement of the backfill and foundation soil. This force helps the structure to resist the overturning action from the earth pressure on the back of the wall. The first four walls were built of limestone, whilst the test section of the fifth was built of a weak slate. Each structure was instrumented, with load cells on the platform itself, and displacement monitoring using draw-wire transducers, photogrammetry, and reflectorless surveying techniques. Because of the large stones resulting in stress concentrations in the wall and backfill behind the wall, information from the pressure cells which were installed was of limited use. Deformations observed during backfilling were small in relation to the height of the walls.

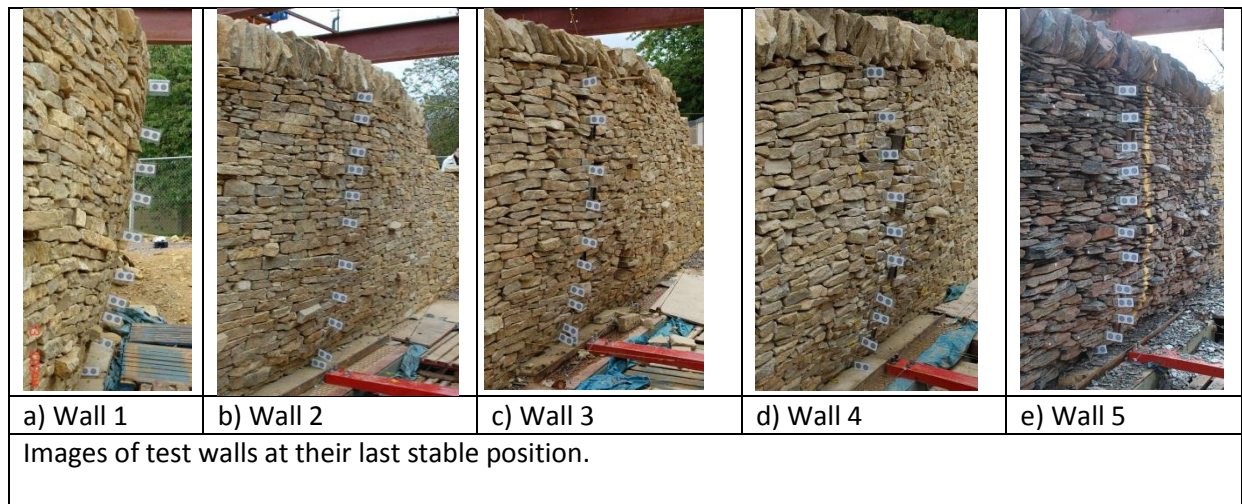
Figure 2 Test walls immediately before collapse

of stones at the face. The horizontal sliding of the slate in Wall 5 is conspicuous, as is the extreme inclination of Wall 1, which was supported by tension along the face of the wall, which resulted in a catenary in plan extending from the lightly loaded section to one side which carried only pressure due to the self-weight of the backfill, through the central test section, to the lightly loaded section on the other side. This is discussed further below. Careful observations were made during the loading of the walls, in addition to the measurements, by multiple still cameras, a continuously recording high definition video camera, and the team of investigators. The observed deformations were seen to arise primarily from the accumulated effects of small rotations of individual stones, but as displacements increased sliding of stone on stone became important. The section of wall carrying the applied load bulged out relative to the adjacent sections, stretching as it did so.

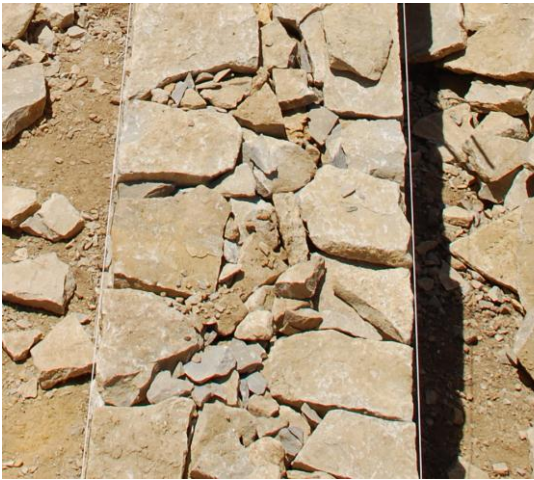
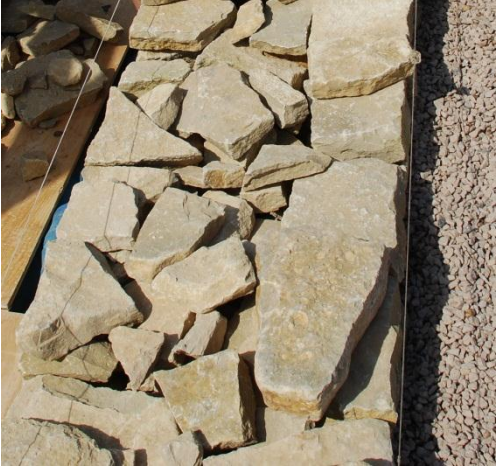
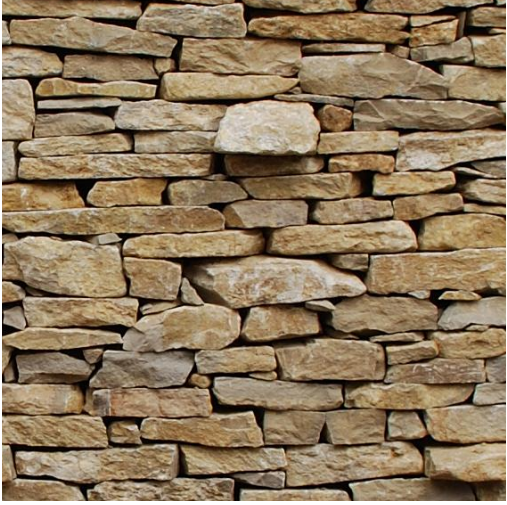
Figure 3 Variations in test wall construction

of the stone in Walls 1 and 3 is compared in Figure 3. Wall 3 included running joints, as in wall 2. The lower density permitted noticeable rotation of individual stones as load was applied. For the most part, such rotations were through relatively small angles from a position which was stable during construction to a position which was stable under the applied loading. The consequent small local movement would result in a small local reduction in the applied load, which might result in a transfer of load to adjacent sections of the wall through friction in the fill, or may result in an overall reduction in the load applied to the wall if the upper part of the wall rotates back slightly against the fill (Figure 4). The accumulation of such small changes in geometry resulted in a configuration which increased the favourable loads while reducing the unfavourable loads, and could better resist those loads.

<p>a) Wall 1 Construction</p>	<p>b) Wall 3 Construction</p>

<p>c) Wall 1 Elevation</p>	<p>d) Wall 3 Elevation</p>

Wall 3 was deliberately built much more quickly with a lower density, and a quality of construction which better reflected common historic practice in the field. Modern professional drystone wallers work to very high standards, producing densely built walls with very few running joints and sufficient through-stones, which span from the front to the back of the wall and hold it together. The packing

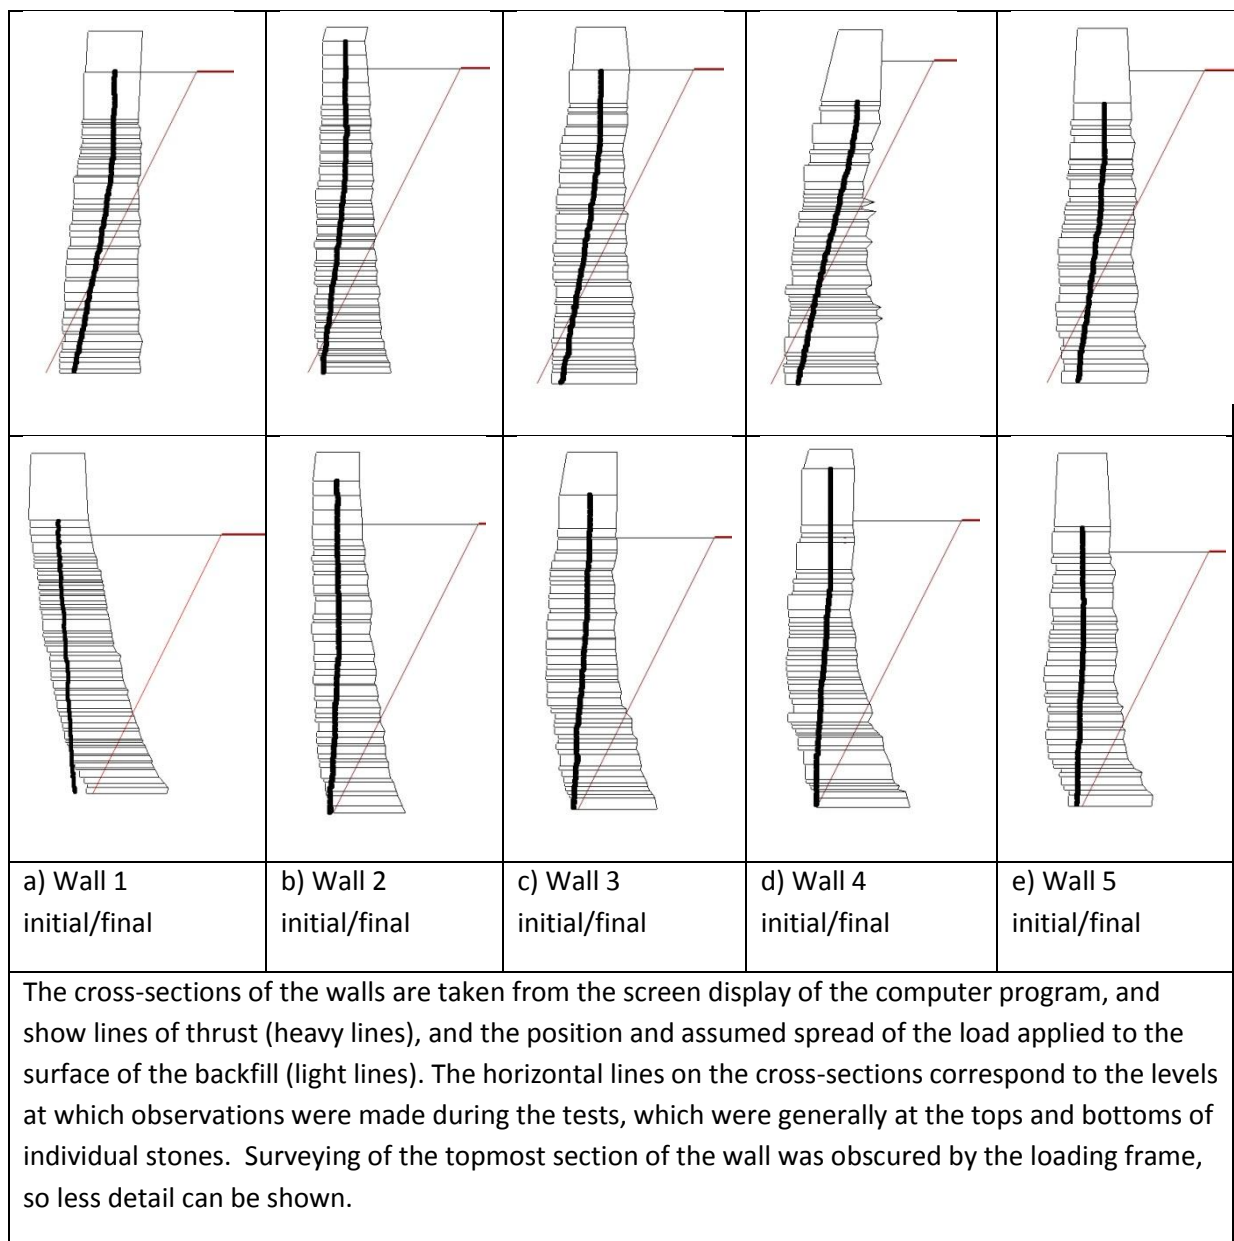
Figure 5 Analysed cross-sections of the walls

This has been explored using the concept of the 'Line of Thrust', defined as the line joining the points of action of the resultant forces between each section of masonry, which has been most commonly used in the assessment of masonry arches[7]. A computer program was written to enable rapid exploration of the effect of changes in geometry, loading and material properties[8,9]. The analysis is simple, taking a cross-section through the wall to be representative of the whole wall, and so all deformations to be in plane strain. The load applied to the plate was assumed to distribute both along the length of the wall and at right angles to the wall, over an area generated by a load spread of 1 horizontal: 2 vertical. The analysis is thus a 2D approximation of a 3D situation. The geometry of each of the test walls was entered into the program based upon the surveyed profiles, and the total forces and moments acting at each level within the wall were calculated using simple Mohr-Coulomb earth pressure theory as used for conventional gravity retaining walls. The results of analysing all five test walls, both on completion of backfilling and just prior to failure, are shown in Figure 5. The cross-sections of the walls are taken from the screen display of the computer program, and show lines of thrust (heavy lines), and the position and assumed spread of the load applied to the surface

of the backfill (light lines). The horizontal lines on the cross-sections correspond to the levels at which observations were made during the tests, which were generally at the tops and bottoms of individual stones. Surveying of the topmost section of the wall was obscured by the loading frame, so less detail can be shown. As the load applied to the fill behind the wall was increased, the line of thrust through the base of the wall moved towards the toe. Failure is expected when the line passes outside the base of the wall, emerging from the wall above the toe. In practice the foundation will probably yield significantly before this point is reached, but as the test walls were constructed on a strong steel platform the correspondence between testing and analysis was excellent.

These results show that the deformed shape which was observed to be stable could be demonstrated to be stable by analysis. The exception is the result for Wall 1, which received additional support via the induced tensile strength along its length, allowing it to remain standing with a line of thrust emerging from the face of the wall. Wall 3, and the corresponding analysis, demonstrated that dry-stone walls can have considerable ductility, and that their characteristic bulging deformation may take them to a position of stable equilibrium. The large deformations prior to collapse give warning of walls in distress, a most important consequence of ductility, while modest bulging need not give concern except in poorly built walls. Detailed observations indicated that deformations are only likely to lead to collapse after individual stones have moved so far that they are losing the support of the stones below them, and the degree of movement involved is related to the size and shape of the stones and the density of construction. The more dense the construction, the less the space between the stones which allows them to rotate, whilst stones which are longer and flatter can rotate less than stones which are more spherical or cubic. On the other hand, as rotation becomes more difficult, sliding becomes more likely, so that ductility arises from translational movements resulting in redistribution of load, while frictional shear resistance between stones is more or less maintained. These are important insights for the assessment of deformed structures. Figure 6a shows where stones fell out of the face of Wall 3 just below the

The fourth test wall was constructed to confirm that the behaviour seen in could be reproduced. Analysis of the first four walls showed the internal friction to be more than sufficient to prevent the wall from sliding forwards on a course of masonry, so the fifth wall was constructed to investigate this type of failure by using slate, with a much lower coefficient of friction between stones. The resulting failure mechanism involved very little rotation, but substantial sliding within the lower courses of the wall (fig 6b), until the wall toppled forwards. Because this failure was triggered by excessive sliding of an individual stone until it tipped over, the final marginally stable geometry was not captured in the data shown in figure 5e, in which the resultant still lies within the base of the wall.

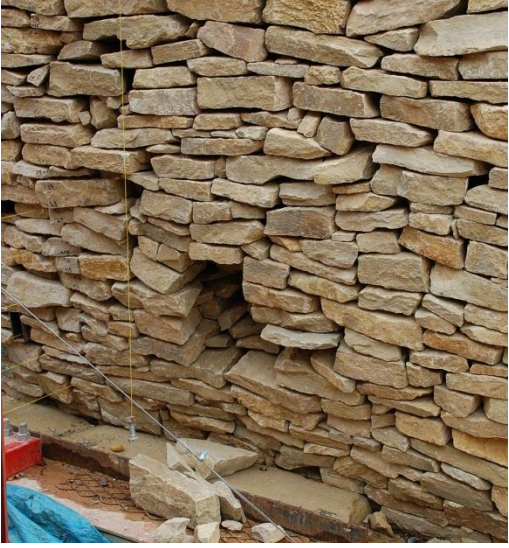
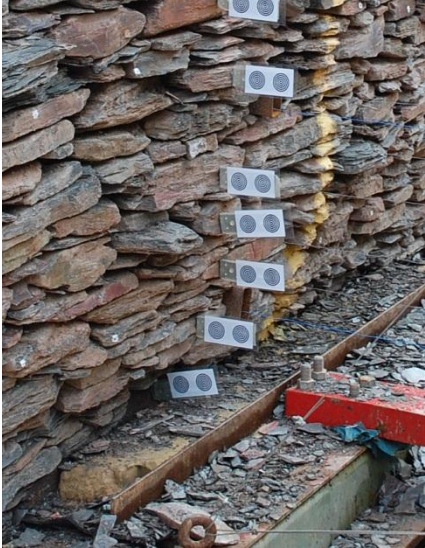
Figure 6 Deformation features within the test walls

bulge; even this significant loss of stone did not lead to immediate collapse, because the stones only fell out because all load was already passing through the adjacent stones, which remained in place.

<p>a) Wall 3: arching within the wall below the bulge</p>	<p>b) Wall 5: sliding of the wall over the lowest courses</p>
